Putting vision first

*Orlaco's front view camera satisfies
European norm for blind spot vision devices*

**ORLACO**
Specialised Camera Solutions

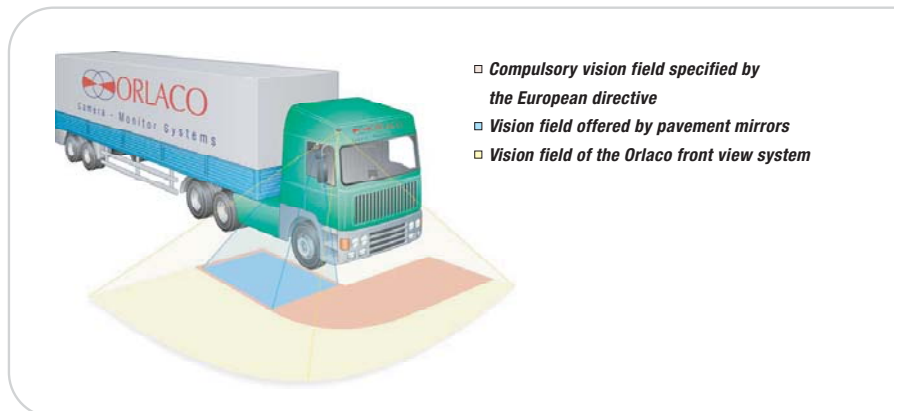
- Compulsory vision field specified by the European directive
- Vision field offered by pavement mirrors
- Vision field of the Orlaco front view system

Vision fields specified by European directive 2003/97/EG

The front vision system provides an excellent field of vision directly in front of and to the sides of the vehicle. Moreover, the Orlaco camera system satisfies European directives, eases vision device monitoring workload as there are fewer mirrors and reduces the risk of accidents. The system is also more cost effective and increases driver satisfaction. It is also easy to expand the front vision system by adding a rear view camera.
